# LANDSLIDE GEOHAZARD SUSCEPTIBILITY MAPPING OF THAE PHYU GONE LANDSLIDE, PAUNG TOWNSHIP, MON STATE

Department of Geological Survey and Mineral Exploration

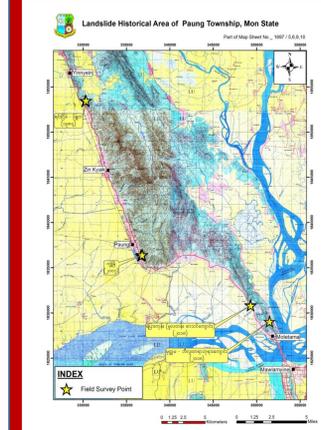
Mudstone, Shale and Siltstone

Right Lateral Fault Sheared Plane

Thae Phyu Gone Landslide

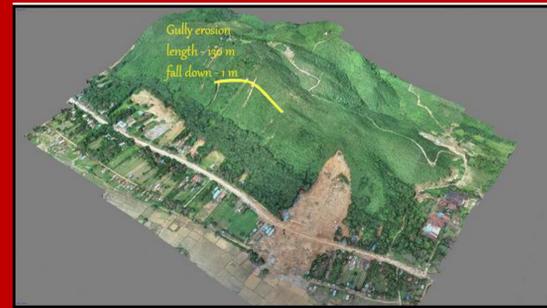
Quartzose Sandstone & Sandstone

Highly Weathered Granite

Mudstone and Siltstone

Weathered Granitic Gneiss
