Recognition of Landslides by the 2018 Hokkaido Eastern Iburi Earthquake Using High-resolution DEM and field survey

Shusaku YAMAZAKI, Yoshihiko ITO, Terumasa NISHIHARA, Toshiyuki KURAHASHI

*Civil Engineering Research Institute for Cold Region,
Public Works Research Institute, Japan*

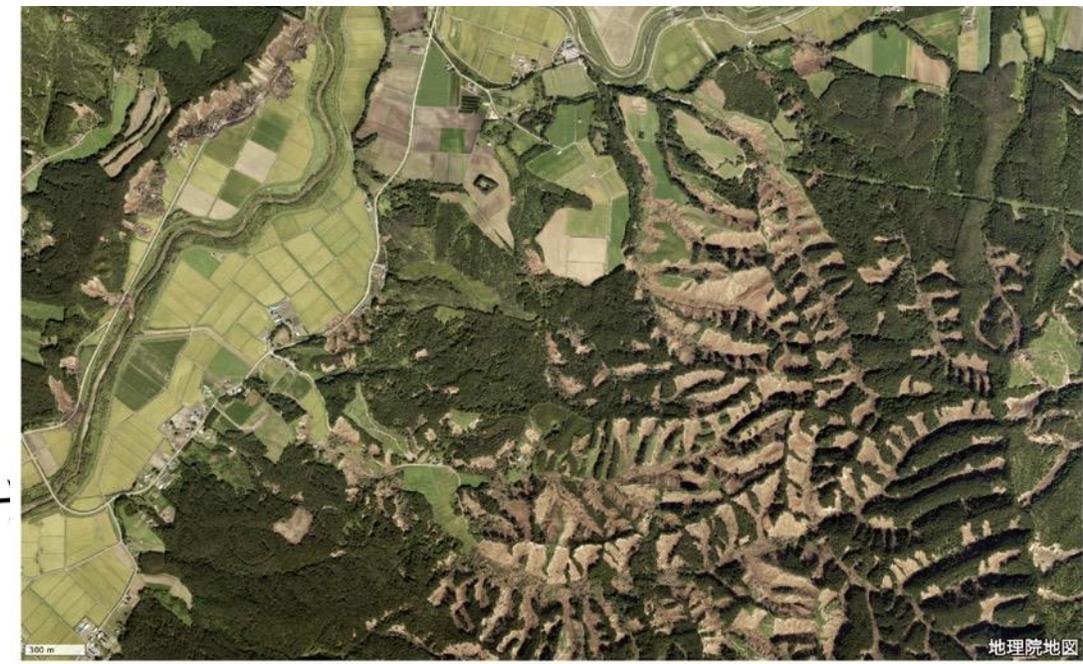
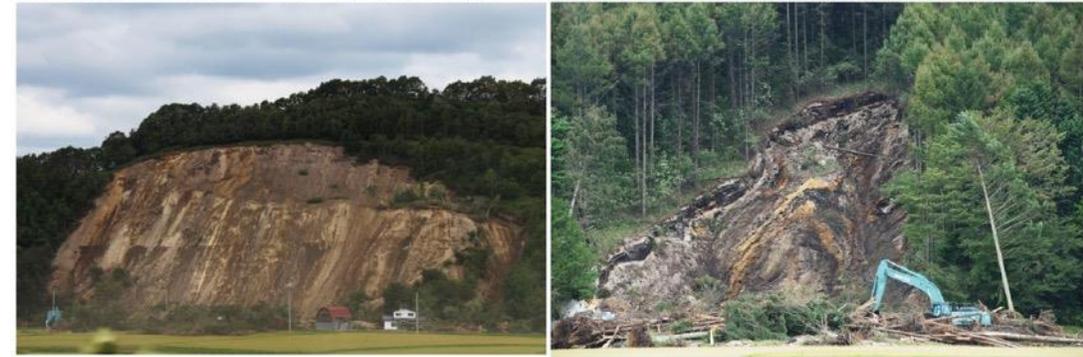
Fig. B Orthophoto image (upper; 5 days after the earthquake by GSI Japan) and photos of typical failed slope (lower).

- The collapsed slope was covered by tephra layers from active volcano of **Mt. Tarumae (Ta-d at 9ka)** and partly with **Mt. Eniwa (En-a at 20ka)** and **Shikotsu Cardera (Spfa-1 at 40ka)** in the northern part.
- The occurrence of the shallow landslides seems to rapidly decrease with thinning of Ta-d layer to <1m thick.

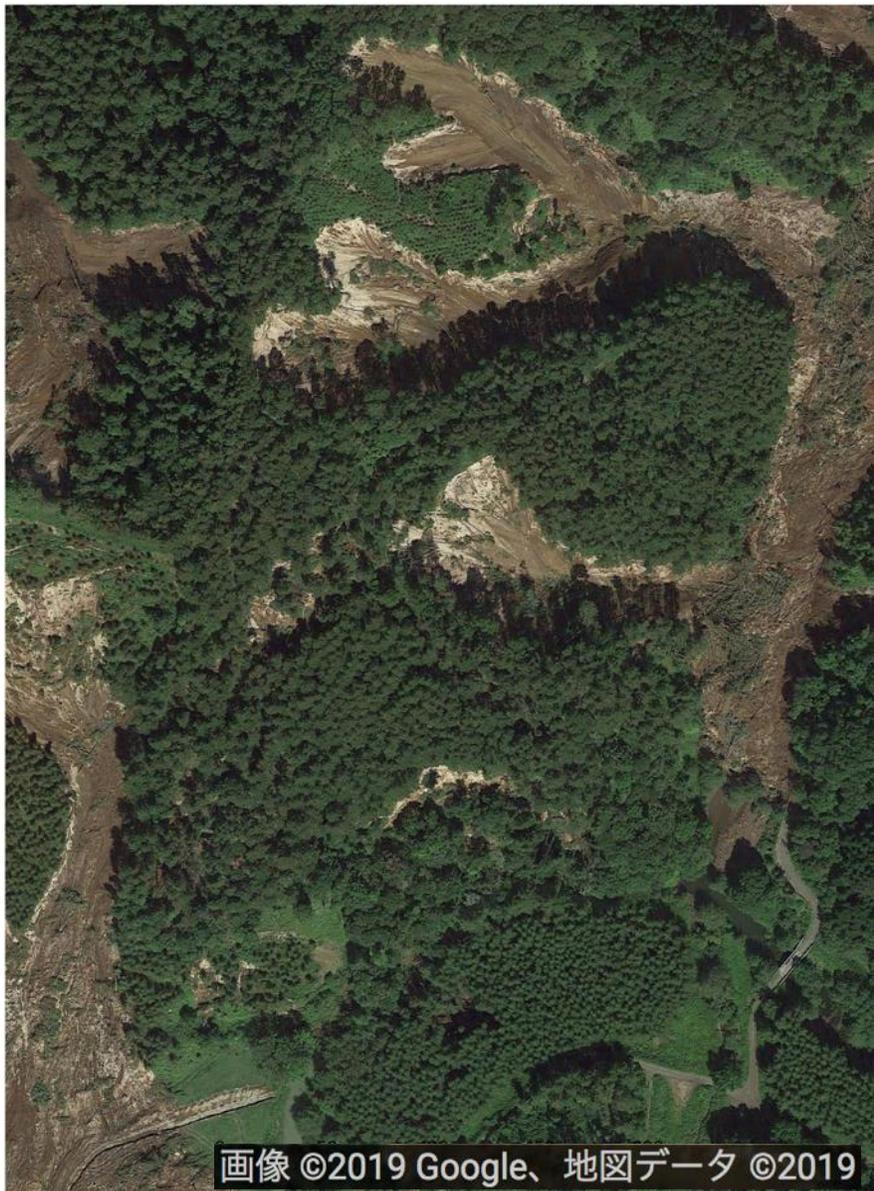
- DEM data of 0.5m in resolution and average point density of 22 points/m².
- Topographic analysis is used shaded-relief map which generate from DEM data in QGIS software.
- Microstructure with >1m in size, such as crack, step, rock block, mound, is clearly discriminable.

Potential of high-resolution DEM

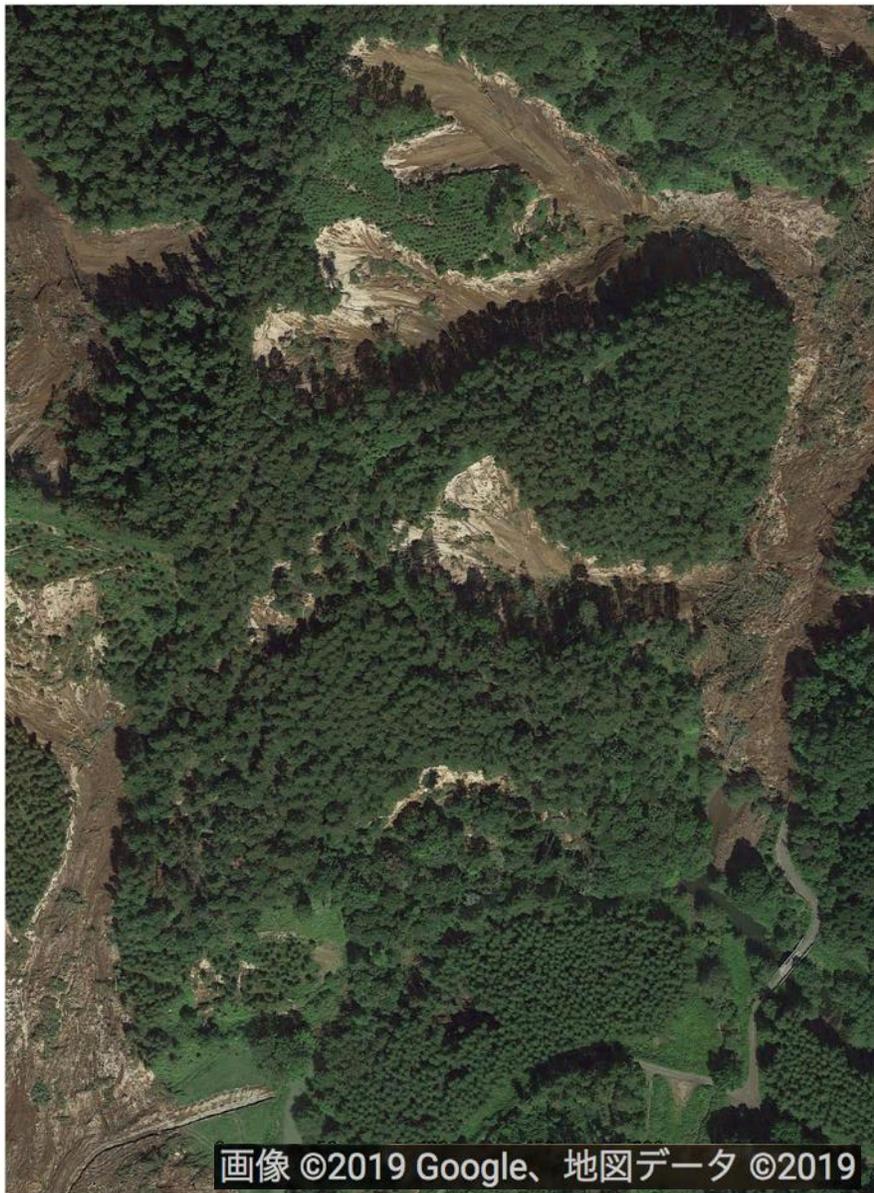
Potential of high-resolution DEM

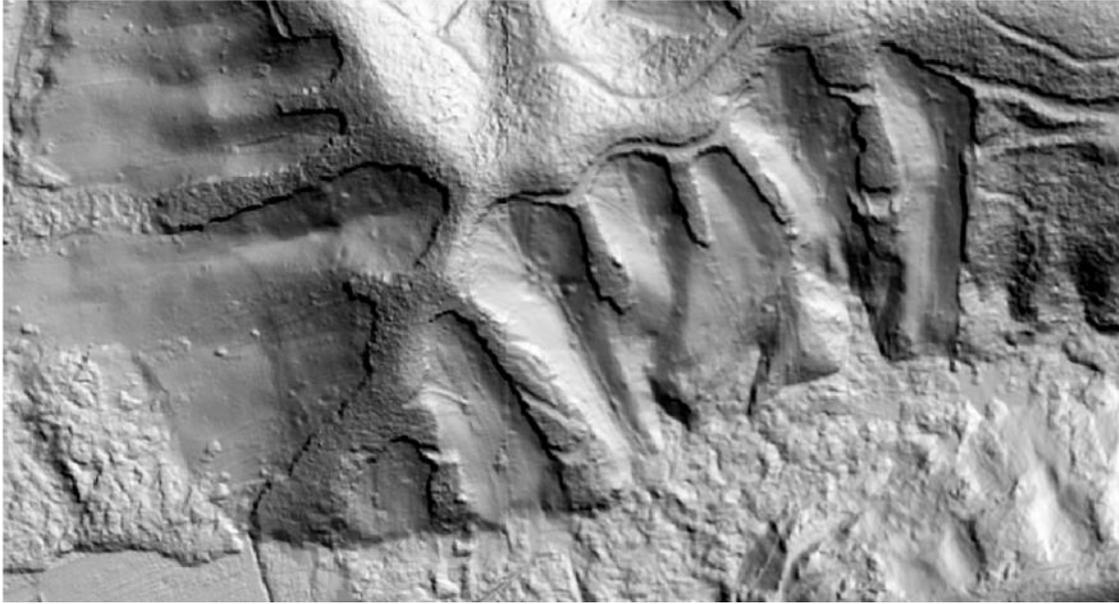
Criteria of rockslide identification in DEM data

- Shallow landslide (earth-slide) of this earthquake is mostly defined by the slide or flow down of mantle bedded tephra layer with **1.5-3 m in thickness** on the slope and **top of failure area dose not over ridge topography.**
- Mantle bedded tephra layer is not enough strong to drag the layer on the top of ridge.

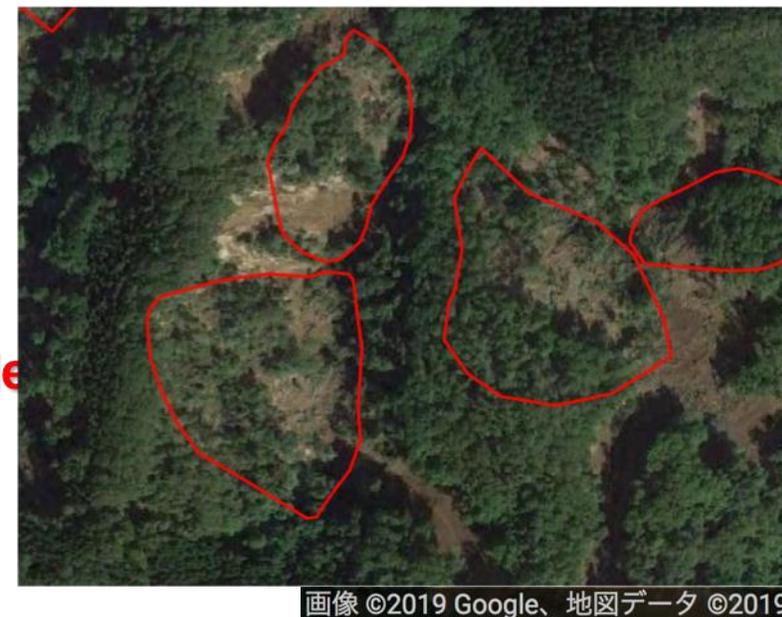
Crack not across ridge & deeper than near ES → Possible RS
