International Conference on Silk-roads Disaster Risk Reduction and Sustainable Development, Beijing International Convention Center, China, 11-12 May 2019

Geohazards of Myanmar (Events & Mitigation Activities)

Myint Naing Exploration Geologist

Department of Geological Survey and Mineral Exploration Ministry of Natural Resources and Environmental Conservation

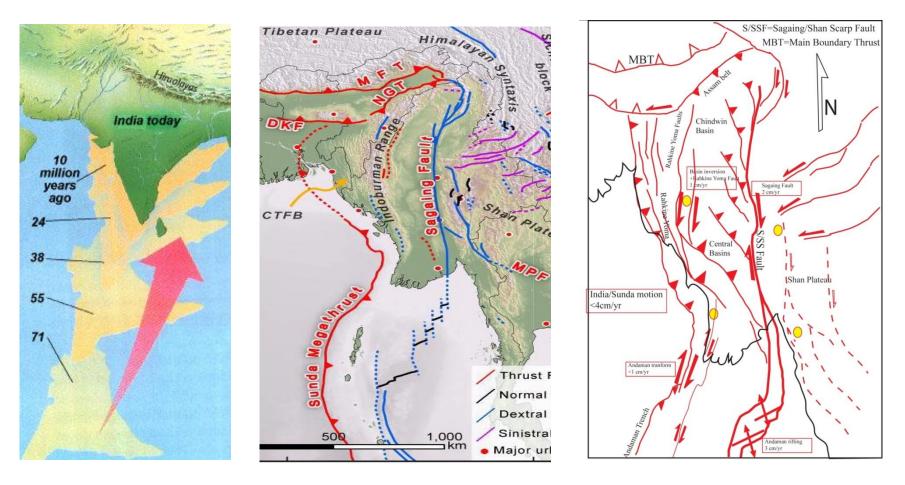
The regional tectonic setting of Myanmar as a result of Indian-Asian collision

- The northward-moving Indian Plate underneath the Burma Platelet at an average rate of 3.5 cm/yr.
- ➤ The northward movement of the Burma Platelet from a spreading centre in the Andaman Sea at an average rate of 2.5–3.0 cm/yr.

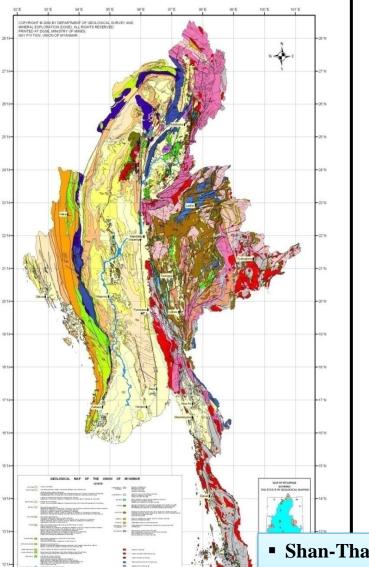
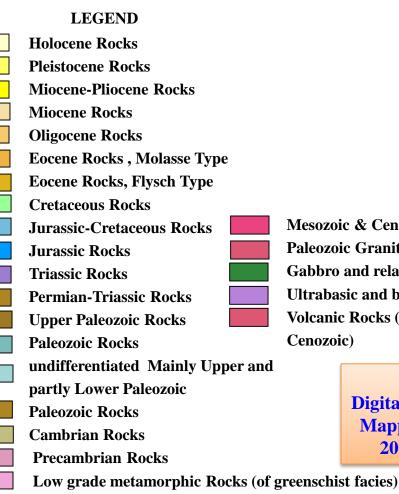
Geological Map of Myanmar (2008)

- Shan-Thai Block includes Precambrian to cretaceous rocks with Slate belt and Mogok Metamorphic belt to the west.
- Central Tertiary sedimentary basins with oil-gas and coal occurrences. The N-S trending Central Magmatic Belt at the centre.
- Western Ranges- fold-thrust belt with Chin flysch.

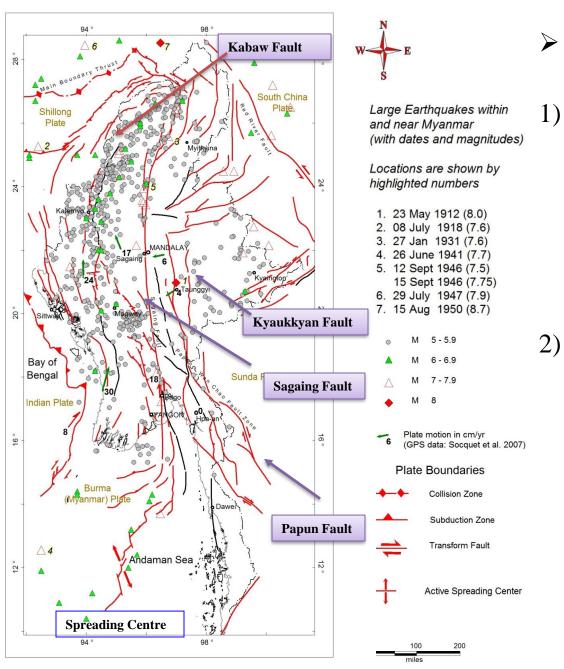
Seismotectonic map

- Earthquakes in Myanmar have resulted from *two main causes* :
 - The continued subduction (with collision only in the north) of the northward-moving Indian Plate underneath the Burma Platelet (which is a part of the Eurasian Plate) at an average rate of 3.5 cm/yr; *and*
- 2) The northward movement of the Burma Platelet from a spreading centre in the Andaman Sea at an average rate of 2.5 3.0 cm/yr (Bertrand et al., 1998; Curray, 2005)

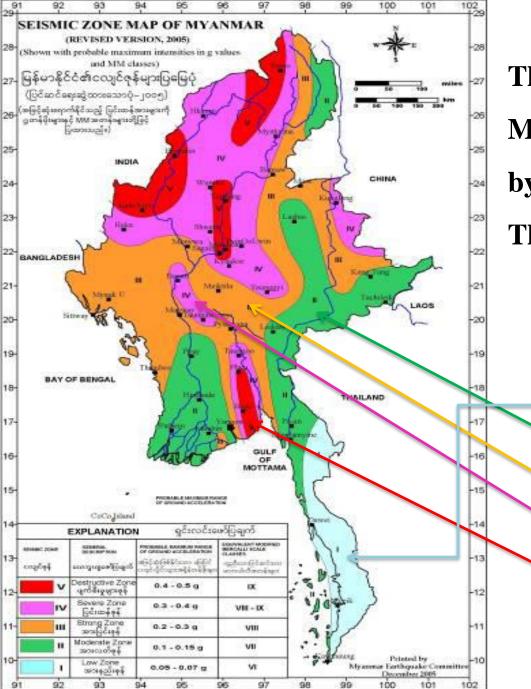
Earthquake The seismic zone map of

Myanmar (2005) was prepared by a team led by Dr Maung Thein during 2003 to 2005

- Five seismic zones are demarcated and named (from low to high)
 - Zone I (Low Zone),
 - Zone II (Moderate Zone),
 - Zone III (Strong Zone)
 - Zone IV (Severe Zone), and
 - Zone V (Destructive Zone)

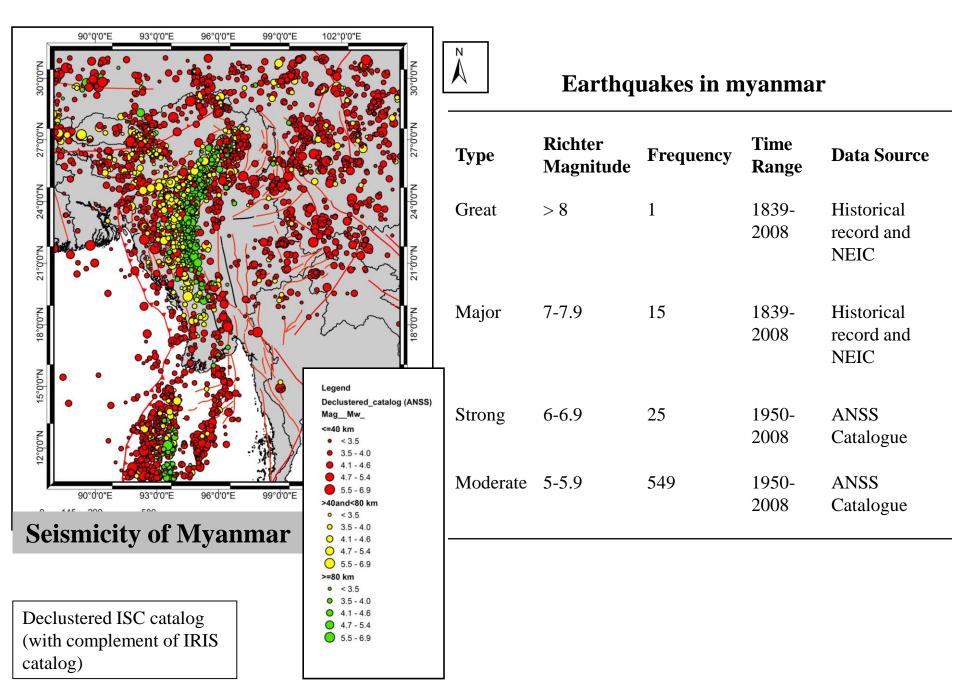
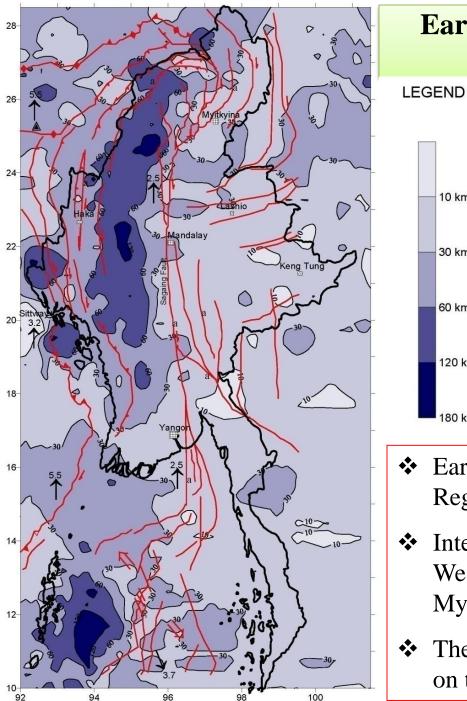
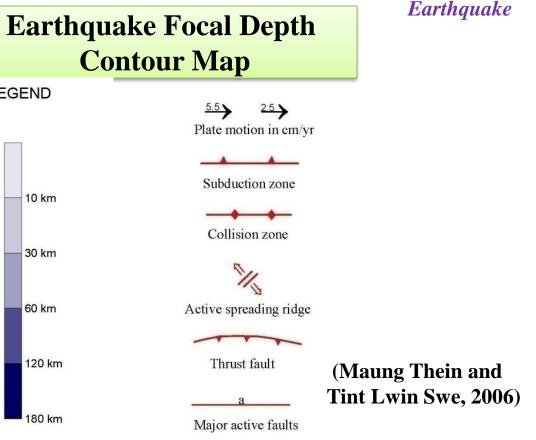
- Earthquake focal depth contour of Myanmar Region in period of 1964-2004
- Intermediate earthquakes occur only in the Western Fold Belt while the other parts of Myanmar experience shallow crustal earthquakes
- The locations of major faults are superimposed on the focal depth zones

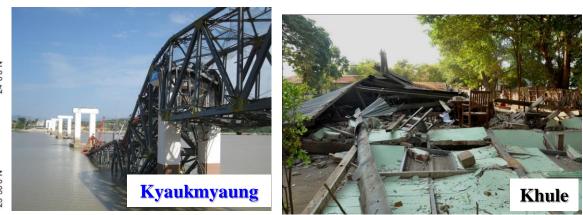
Sept 12, 1946, 15:17:15 (7.3) Sept 12, 1946, 15:20:20 (7.5) Gutenberg & Richter, 1954

☐ Mw – 6.8, (about 10 km focal depth)
☐ Nov. 11, 2012 (7:50 am, Local time)
☐ 26 casualties, 231 injuries
☐ various sort of buildings (>500) damaged
☐ Source – right- lateral Sagaing Fault

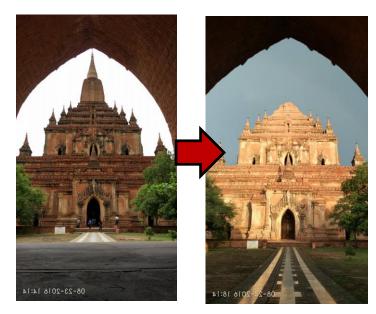
6.8 Mw Bagan Earthquake, Myanmar (24.Aug.2016)

23 Aug 2016

24 Aug 2016

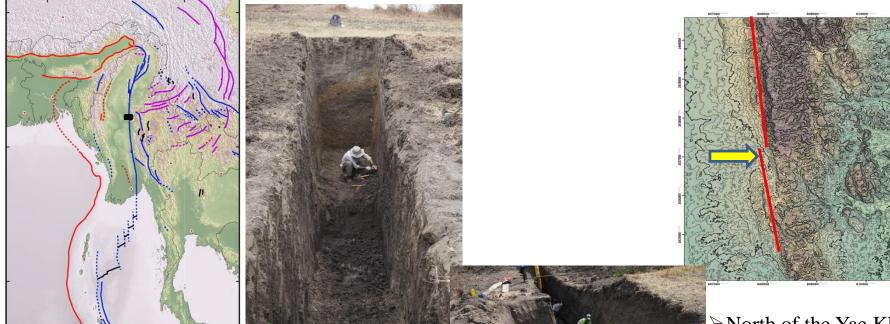
Earthquake Geology Field Train along the Sagaing fault (March, 2016)

- Paleoiseismology
- ✤ Geological mapping of active fault
- ✤ GPS survey
- Ground LiDAR topography survey

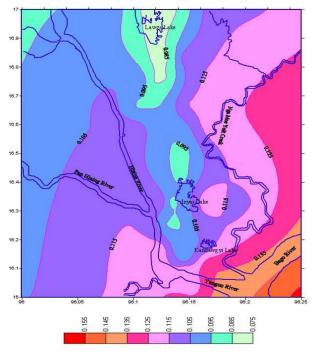
Yangon seismic zone map

EARTHQUAKE ZONING MAP OF YANGON AREA (TINT LWIN SWE, 2004) Characteristic earthquake of 7.3 Mw and mean ground motion at firm rock using attenuation relationship of NWA Model (Boore et al, 1997).

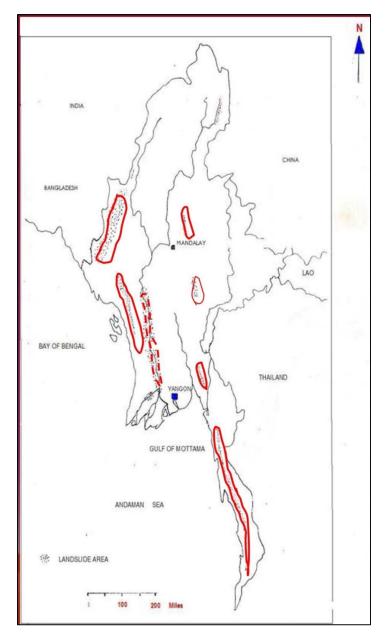
Landslide Hazard Zone Map of Myanmar

- The main factors that influence landslides in Myanmar are mainly classified as follow:
 - a) The gradient of the slope
 - b) Hydrologic characteristic of the slope
 - c) The presence of trouble some earth materials
 - d) The process of erosion
 - e) Man-made causes
 - f) Geological conditions
 - g) The occurrence of a triggering event

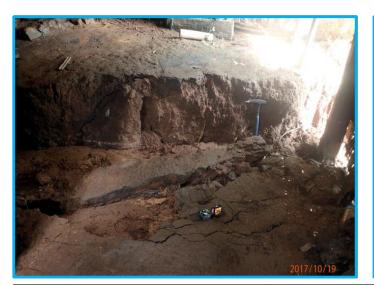
7. Thit Seint Gon Landslide

Many crack signs appeared and the car road was uplifted owing to creep the soil after the continuous heavy rains.

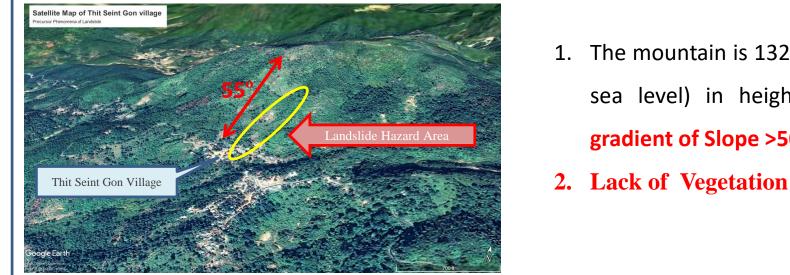
The mountain is 1320 m (above sea level) in height and the gradient of Slope >50°

3. The Torrential rainfall [The annual rainfall is 2000mm to 4000mm (Humid Climate)].

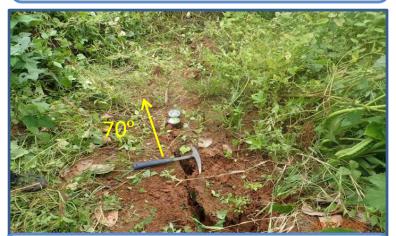
6. Local fault and direction of crack signs. $(Generally = 70^{\circ})$

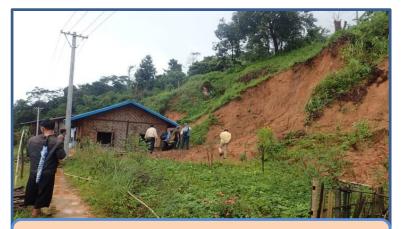
5. Poor Drainage System (Increasing Pore Water Pressure)

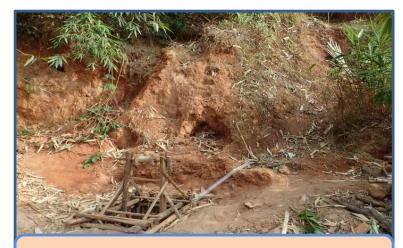
7. Human Activities (Old pit of Gemstone Mining activities)

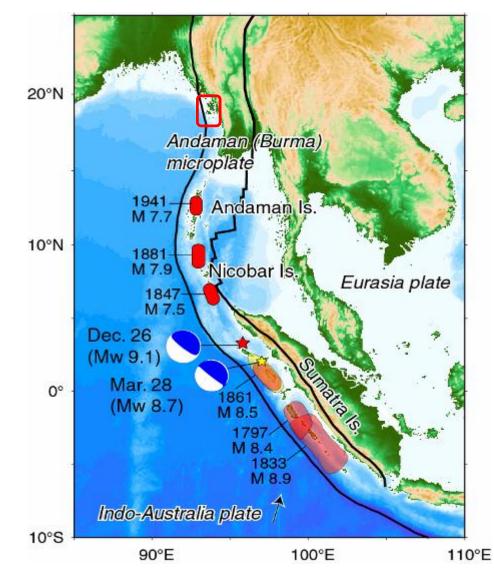
The past earthquake and tsunami events in and around the Sunda Trench

1750	Cheduba Island
	Myanmar
1762 April 12	Bay of Bengal
1797Feb 10	Sumatra
1833 Jan 29	Sumatra
1861 Feb 16	Sumatra (Mw 8.5)
1881 Dec 31	Bay of Bengal
	(Mw 7.9)
1883 Aug 27	Sunda Strait
1941 June 26	Andaman Island
	(Mw 8.1)
2004 Dec 26	Sumatra (Mw 9.1)
	、

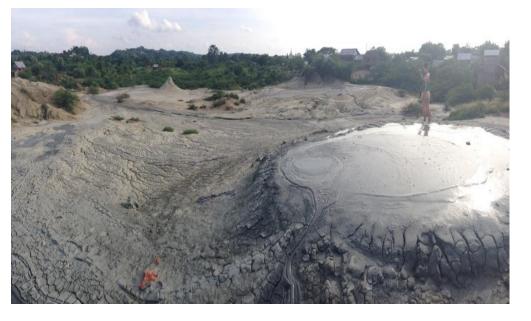
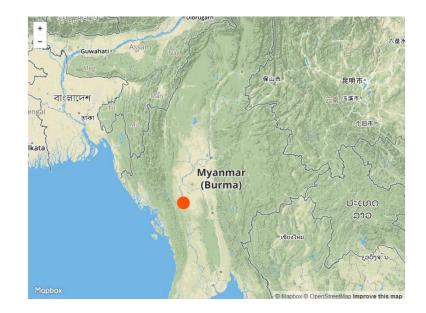
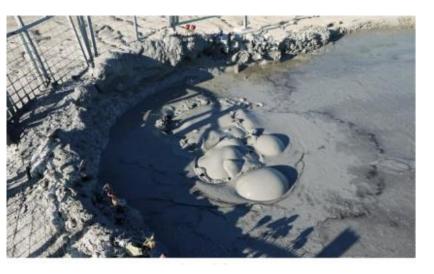
- Minbu mud volcano is situated on the western Range, near the oil-field of Yenangyaung (Upper Burma)
- ➤ are small hillocks of grey mud or clay
- The hills begin as holes, from which mud oozes and forms continually growing cones
- Inflammable gases are also exuded with the mud
- there is no heating involved, the mud is cool to touch
