Heavy Rain and Landslide Disaster of July 2018 in Western Japan

Tomohiro NISHIMURA (Kokusai Kogyo Co., LTD)

**Working Group on Geology Related to Disasters
in Japan Society of Engineering Geology (JSEG)**

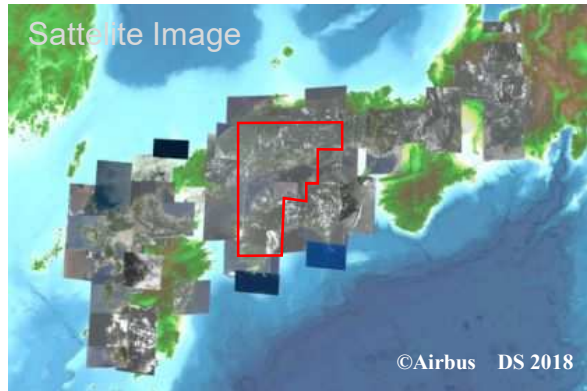
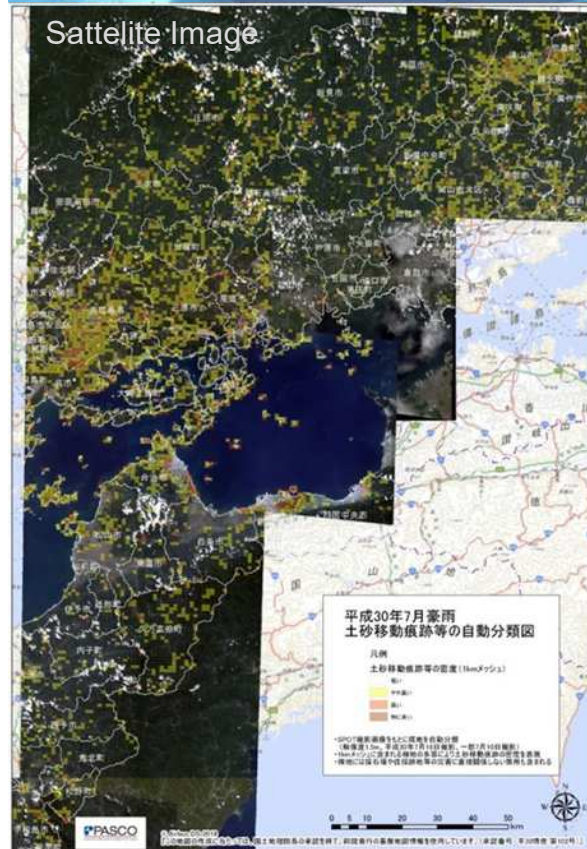
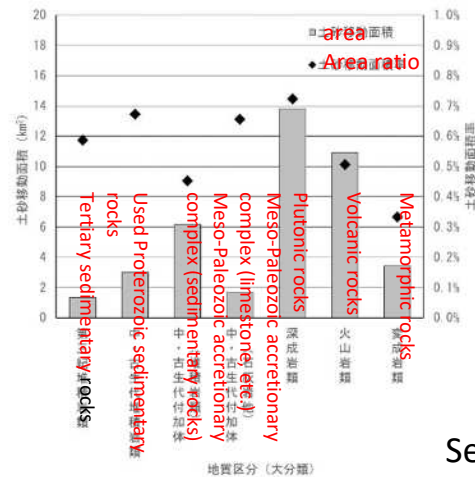
Estimation of Wide Area Distribution of Sediment Disaster Using Optical Satellite Images

The amount of sediment movement by geology was investigated by overlaying the sediment movement density map and the geological map.

>> Most frequently occurring in plutonic rock (granite) areas

Sediment transfer rate by geology

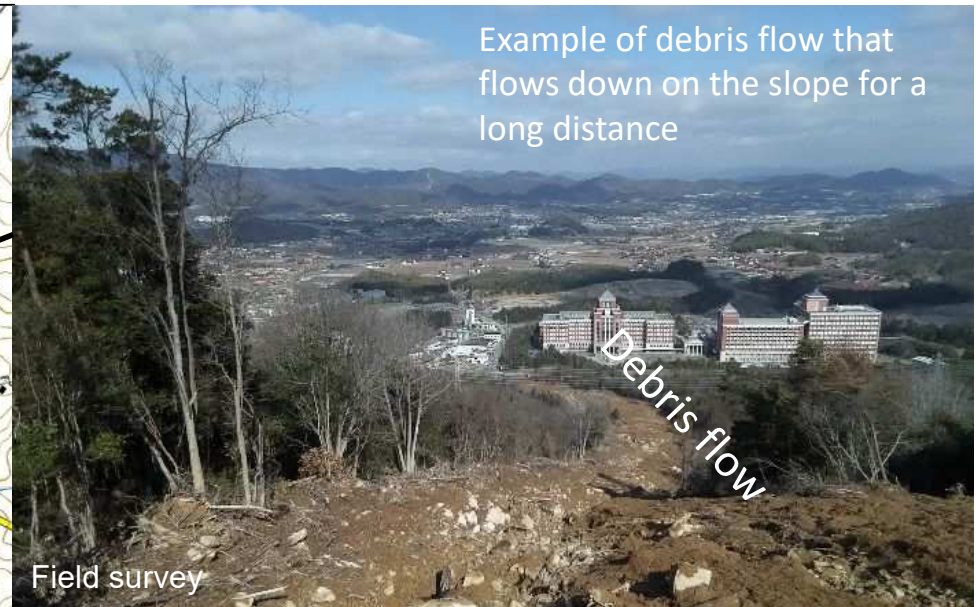
Specific characteristics and disaster situation of debris flow

In the area where **Rhyolite** is distributed, it was observed that the shallow landslides that occurred on the hillside **flows down on the slope for a long distance** instead of valley

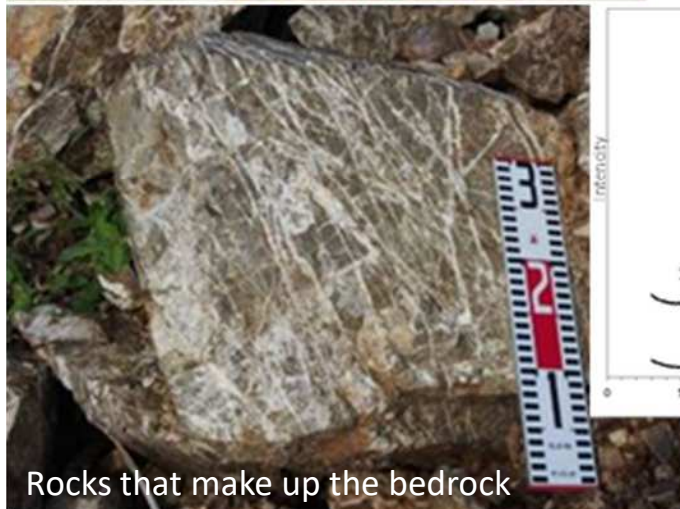
Cross-section of Landslide

Observation of Landslide scarp and colluvial deposit revealed **many white veins in the rocks**. As a result of analysis by X-ray diffraction method these veins, it was found that a lot of **Laumontite** was contained. It is known that the volume change of Laumontite occurs due to dry and wet conditions

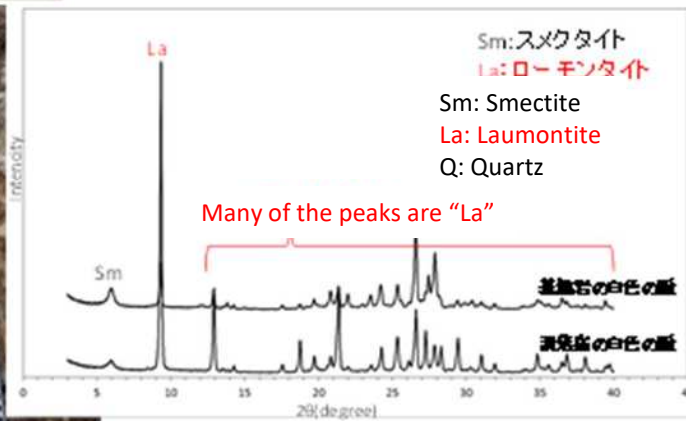
Analysis by X-ray diffraction method
